2023: Port of Arendal

Eydehavn main quay: A slipp of rocks observed under Main quay Eydehavn (red triangle)

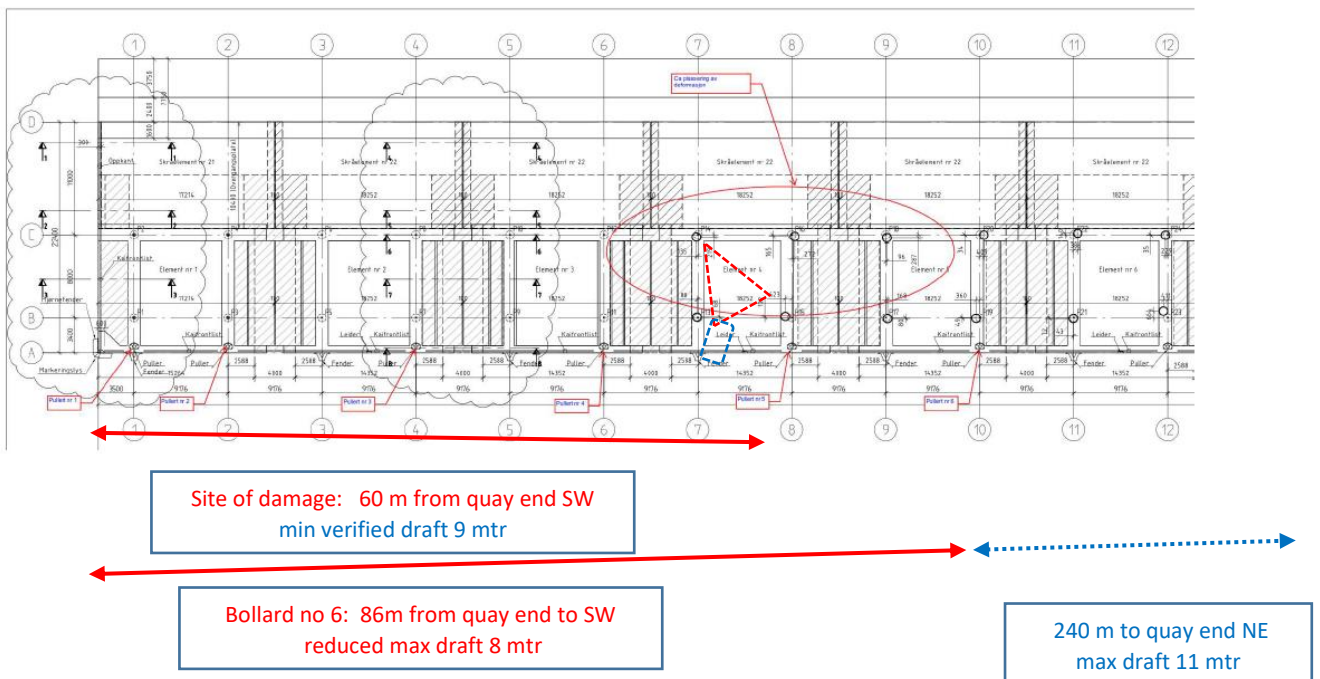
- Reduction in max vessel draft alongside to **8 mtrs** from bollard no 6 (86 m) until quay end in SW
(Verified minimum depth in damage area (**blue area**/ **rock observed**: 9 mtrs):
- No crane operation/ loading/unloading between bollard no 4 and no 6. Area is physical cordoned off

Pile no 14 affected by the slipp. All other piles verified intact

All bollards/fenders/ intact and verified for securing vessels alongside

By immediate effect until further notice
